FIELD INSPECTION REPORT

Project Name:	Mountain Valley Pipeline	Inspector:	Matthew Grant
Inspection Date:	Tuesday, March 9, 2021	Project Contact:	Brian Clauto
Spread H: Montgomery	ST12544+06-12518+00	Weather:	Dry

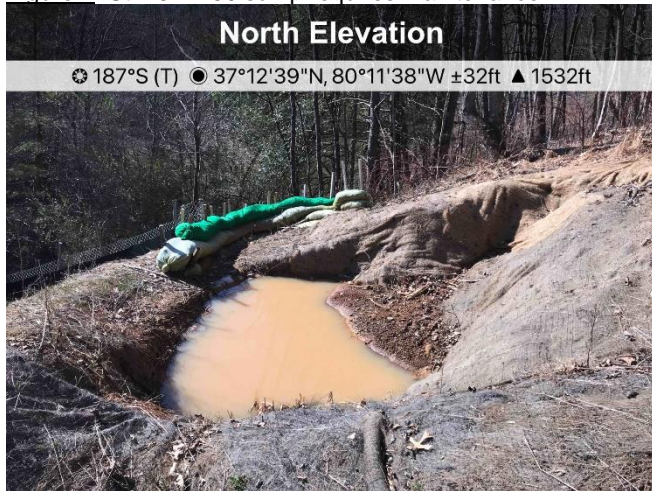
- Figure 1: St12542+50 sump requires maintenance.

- St12542+50 sump requires maintenance
- St12527+25 stockpile has slipped and requires maintenance
- St12525+53 & St12522+50 trash requires cleaning located in sumps

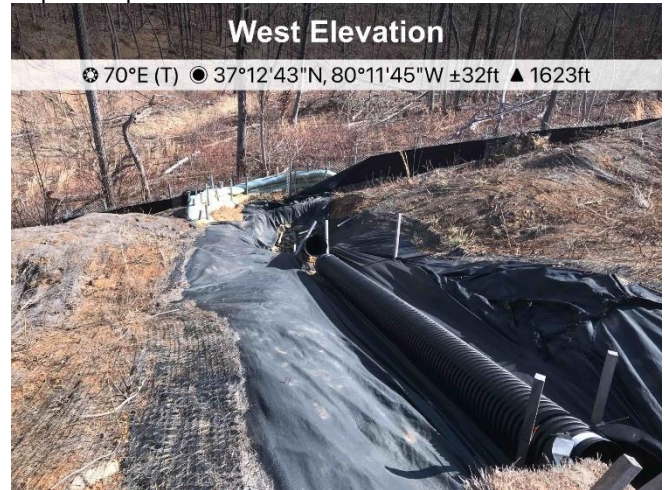
- Figure 2: St12535+48 slope drain pipe is detached and requires repair.

- St12535+48 slope drain pipe has become disconnected and requires repair

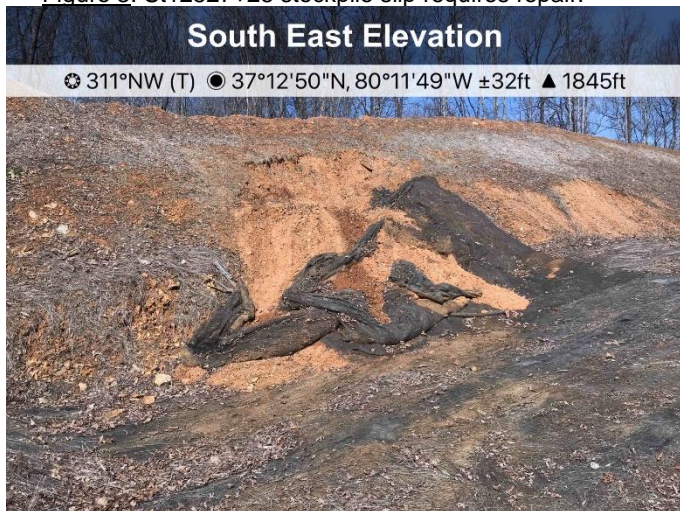
- Figure 3: St12527+25 stockpile slip requires repair.

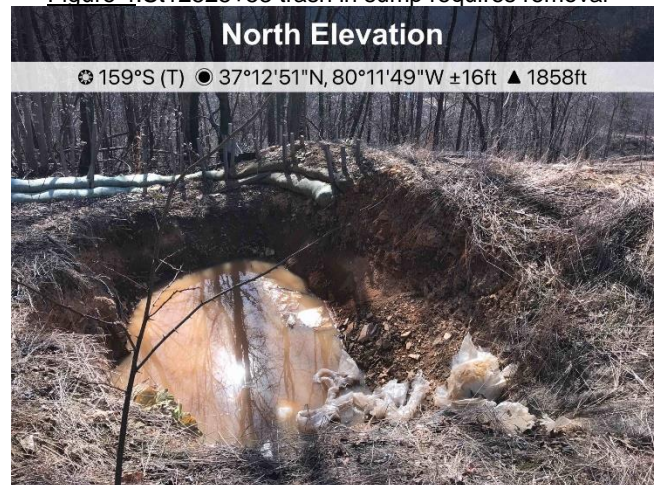
- Figure 4: St12525+53 trash in sump requires removal

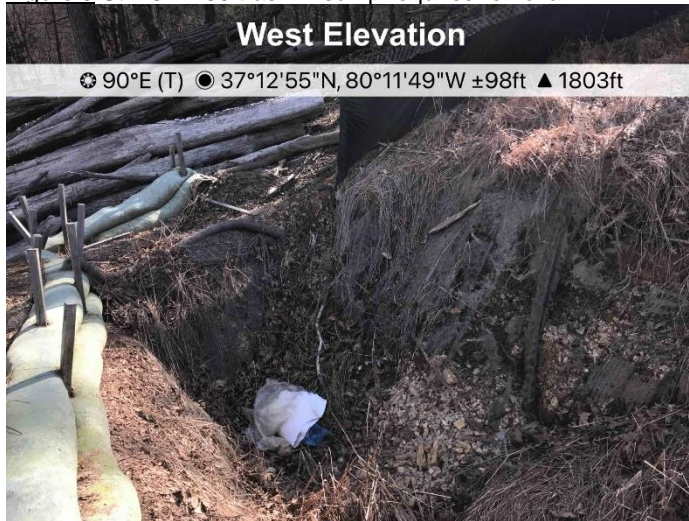
Figure 5: St12522+50 trash in sump requires removal

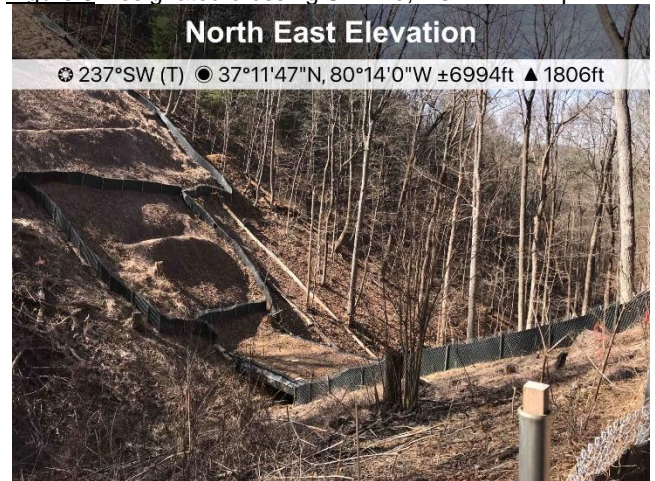
- Comments: Inspected the following resources: S-EF19
- ECD's were in place and functioning at the designated crossing.

Figure 6: Designated crossing S-EF19, ECD's are in place.

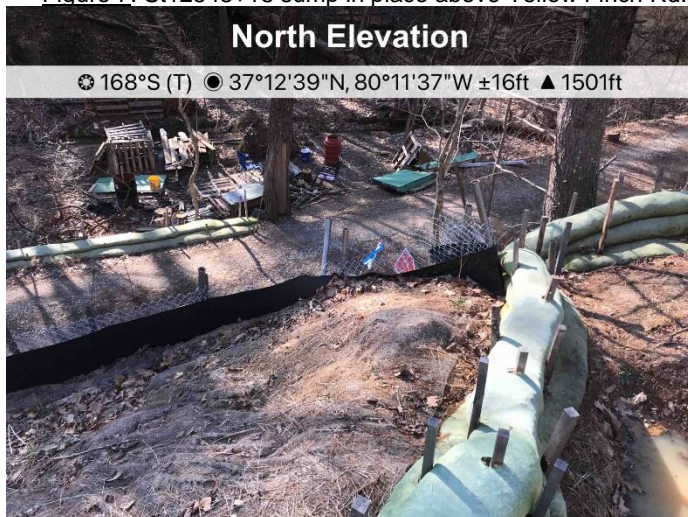
Figure 7: St12543+18 sump in place above Yellow Finch Rd.

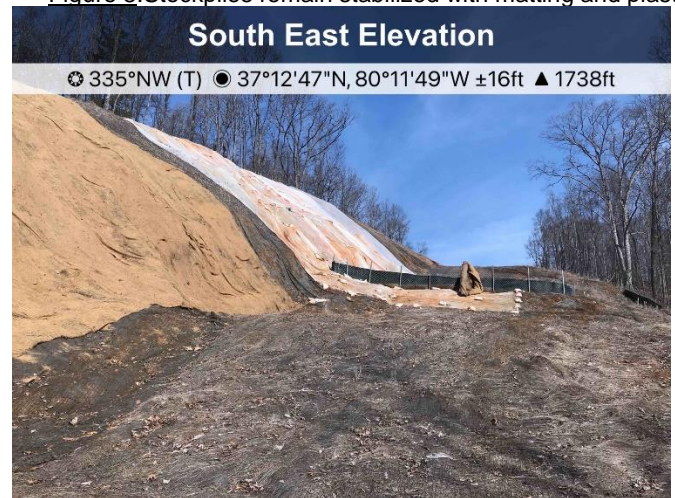
Figure 8: Stockpiles remain stabilized with matting and plastic.
